DEPARTMENT OF NATURAL RESOURCES

Division of Oil, Gas and Mining
JOHN R. BAZA
Division Director

Minerals Inspection Report

Mine Name: Coyote Knoll 1-2-3 2	Permit Number: S/023/0086	Mine Status: Active
Operator Name: Amnor Energy Inc.	Inspection Date: 04/03/2015	Permit Fees: Paid
Inspector(s): Wayne Western	Inspection Time: 10:00 - 10:40 PM	Bond Amount: \$36,100
Attendee(s): Joelle McCarthy BLM	Weather: sunny mild temp	Bond Escalation: 10/26/2015
Inspection Purpose: Operator requested bond release		Prior Inspection: 03/11/2014

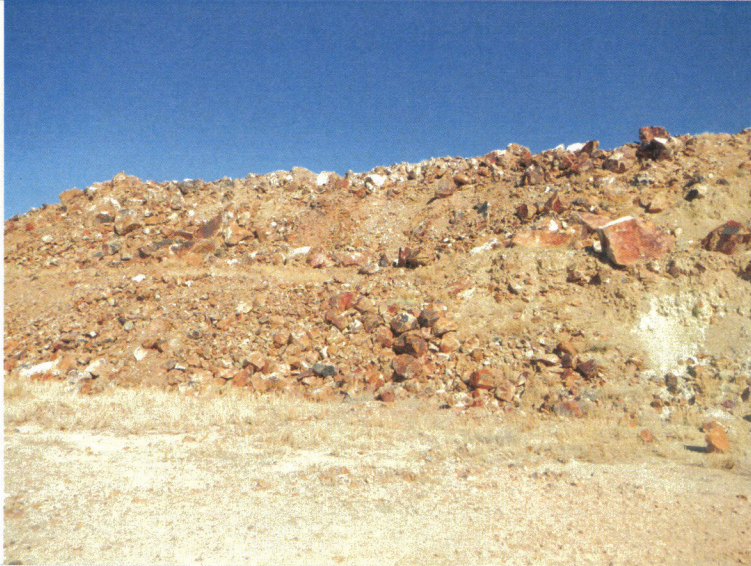
2.	Public Safety (shafts, adits, trash, signs, highwalls)	<input checked="" type="checkbox"/>	<input type="checkbox"/>
There are slopes on the site that exceed a 45 degree slope. The Division does have concerns about having steep slopes on the site. The Operator has indicated a willingness to reduce the slopes during reclamation.

Photo taken inside the pit looking north. Slopes are steeper than 2H:1V. Slopes are steeper than 2H:1V

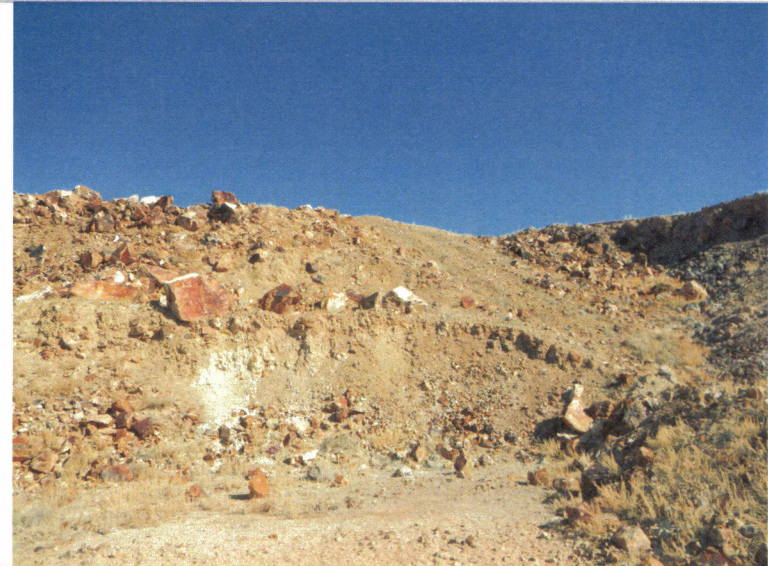
Photo taken inside the pit looking north. Slopes are steeper than 2H:1V

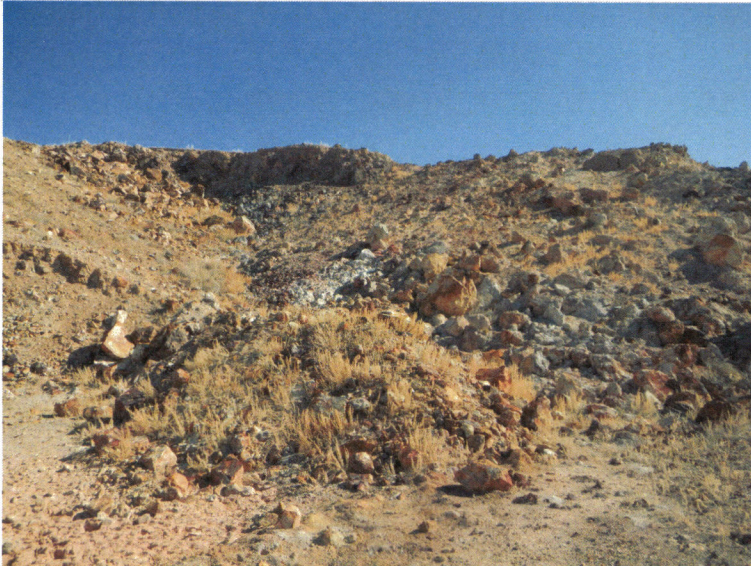
Photo taken inside the pit looking east.

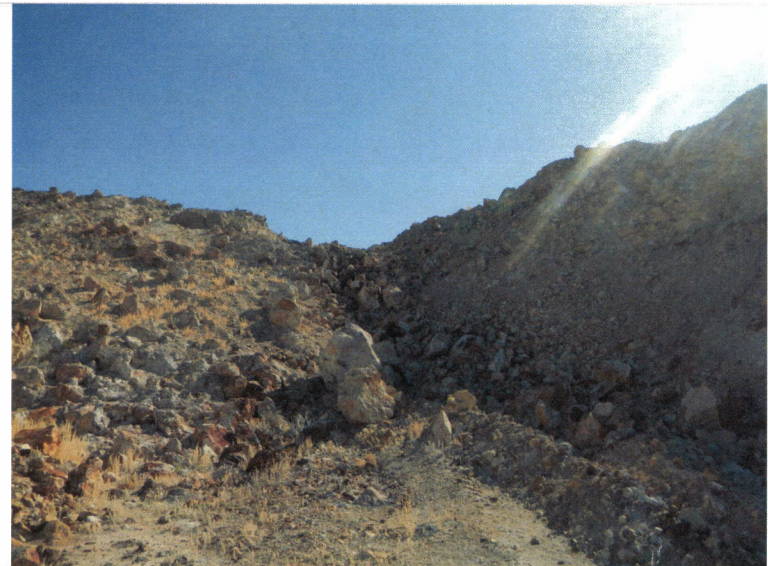
Photo taken inside the pit looking south east.

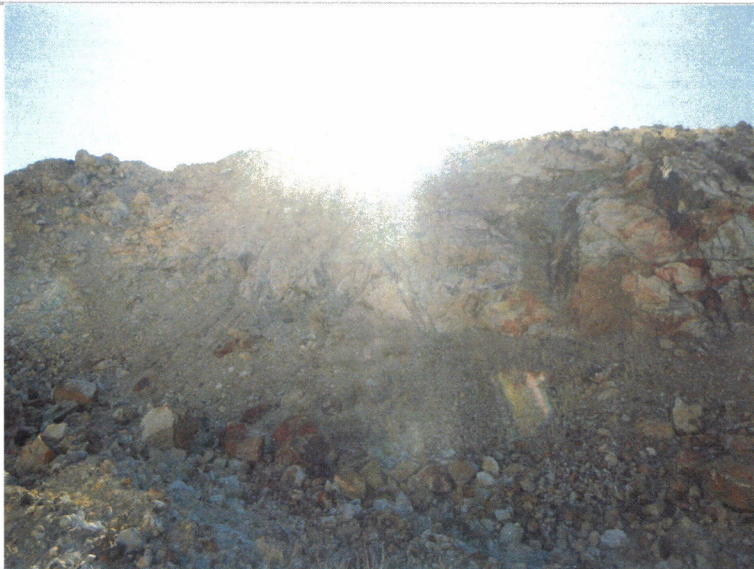
Photo taken inside the pit looking south. Note highwalls.

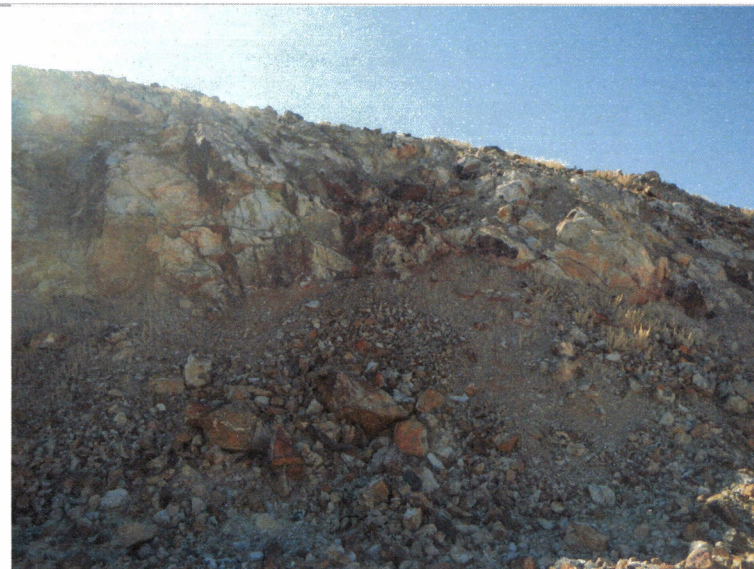
Photo taken inside the pit looking south. Note highwalls.

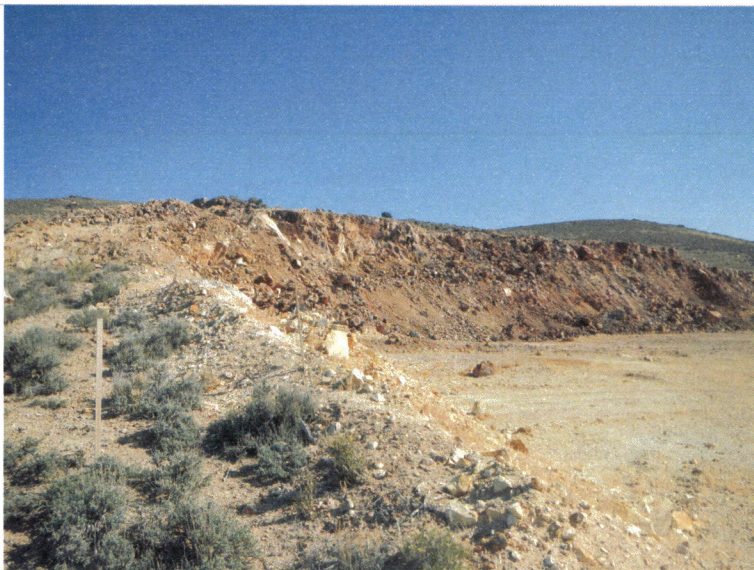
Looking at pit from the pad area

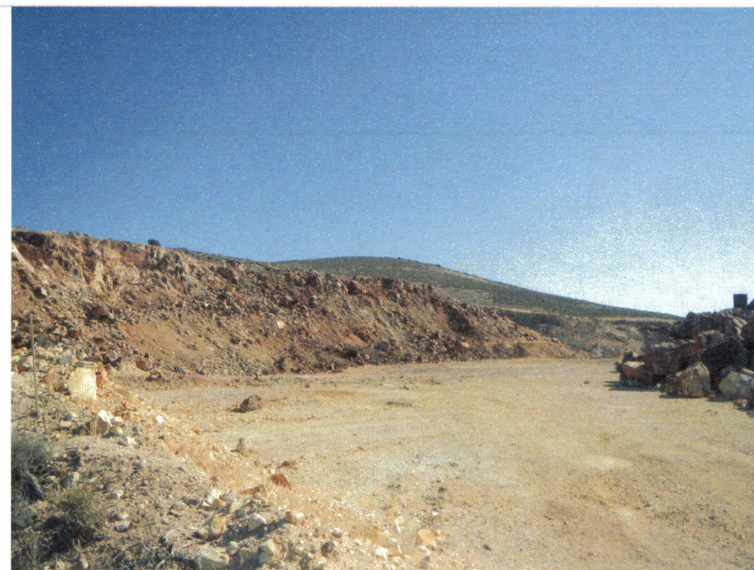
Looking at pit from the pad area
